# Glass Lined Steel Shaft Repair

ID: 9046

Industry: Chemical & Petrochemical  
Application: FBC-Fans, Blowers and Compressors

Substrate: Carbon steel  
Products: Belzona 1511 (Super HT-Metal), Belzona 1593, Belzona 9111 (Cleaner Degreaser)

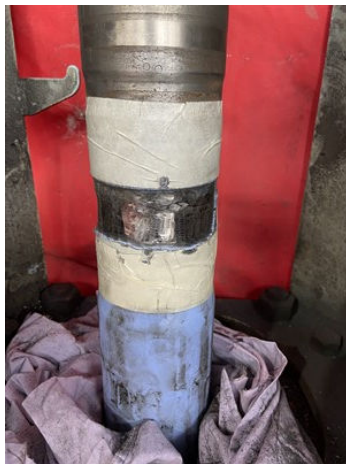
After surface preparation was completed on the defect area.

1. The repair area was not immersed. The shaft was out of service and was able to be repaired in place. Access was achieved by scaffold. The defect area was taped off.
2. We used a grinder with cutting disk to remove a minimum of 1/16" of metal and to roughen the surface. The area was then wiped clean with Belzona 9111 and allowed to dry.
3. Next, we mixed Belzona 1511 and scrubbed it into the profile to rebuild to the original shaft OD as best effort. An applicator was used to make the Belzona 1511 smooth.
4. Belzona 1593 was applied in one coat by brush to seal the damaged area.
5. The following day we came back to look for any pin holes or holidays in the coating, and none were found.

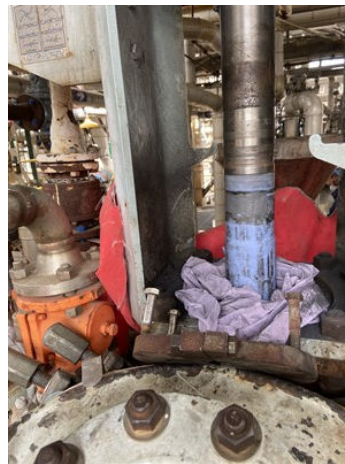
Shaft rebuilt with Belzona 1511 (high temperature paste grade system).

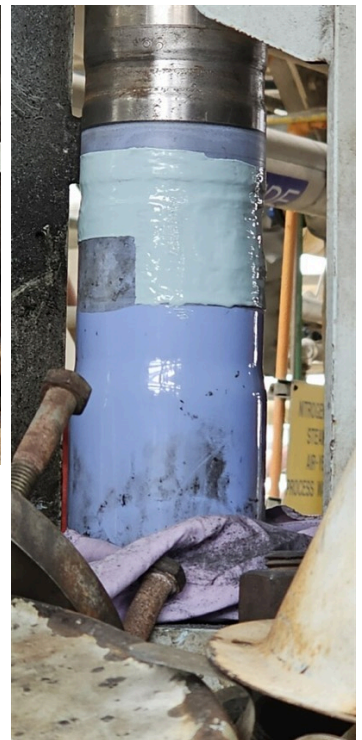
Belzona 1593 (high temperature coating) applied to seal the area.
