# Rebuild and Protection of Discharge Elbows on a Francis Turbine

ID: 9047

Francis turbine elbows within a Hydroelectric Power Station.

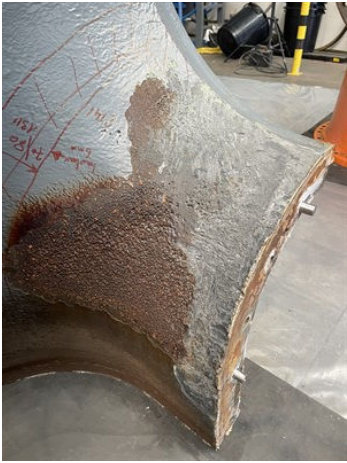
The discharge elbows of Francis turbines suffered severe cavitation-erosion in the inferior areas.

Damage caused by erosion-cavitation leading to a substrate loss greater than 5mm.

The areas affected by cavitation were reloaded using Belzona 1311. All elbows were then coated using Belzona 1331 or Belzona 1341. The most cavitation-intense zones were then further top coated using Belzona 2141 (an Anti-Cavitation Resistant Elastomer). The application was carried out in accordance with Belzona System Leaflet VPF-01 & VPF-02.

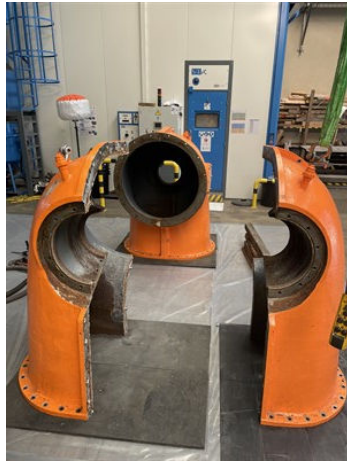
All elbows viewed together.

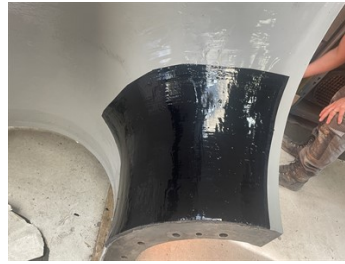
Post substrate rebuilding, the first coat of Belzona 1341 and Belzona 2141.

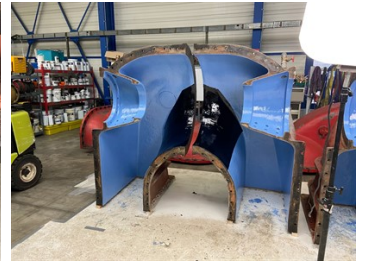
Final application showcasing Belzona 1431 and Belzona 2141.
