Rebuild and Protection of Discharge Elbows on a Francis Turbine

ID: 9047

Francis turbine elbows within a Hydroelectric Power Station.

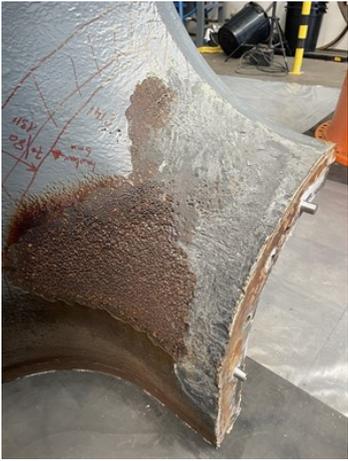
Damage caused by erosion-cavitation leading to a substrate loss greater than 5mm.

The areas affected by cavitation were reloaded using Belzona 1311. All elbows were then coated using Belzona 1331 or Belzona 1341. The most cavitation-intense zones were then further top coated using Belzona 2141 (an Anti-Cavitation Resistant Elastomer). The application was carried out in accordance with Belzona System Leaflet VPF-01 & VPF-02.

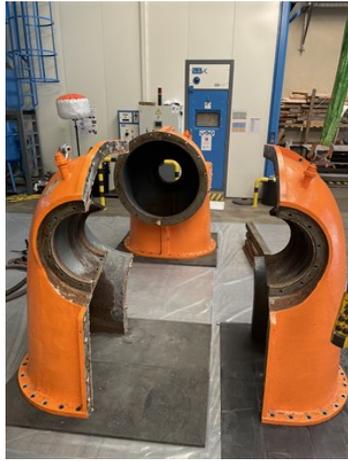
All elbows viewed together.

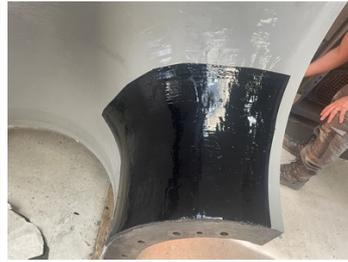
Post substrate rebuilding, the first coat of Belzona 1341 and Belzona 2141.

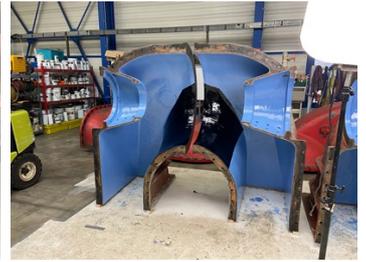
Final application showcasing Belzona 1431 and Belzona 2141.
