Pump Casing Internal Repair

Application: CEP-Centrifugal Pumps

Customer Location: Pasadena, TX, USA

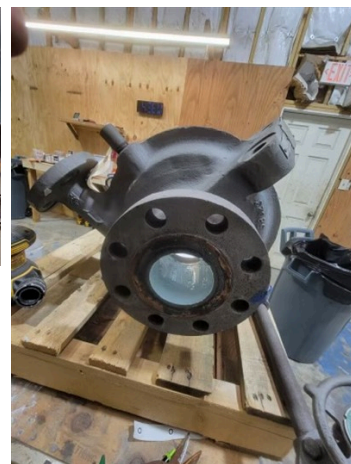
Back side view of completed project.
