Pump Casing Internal Repair

ID: 9049

Application: CEP-Centrifugal Pumps

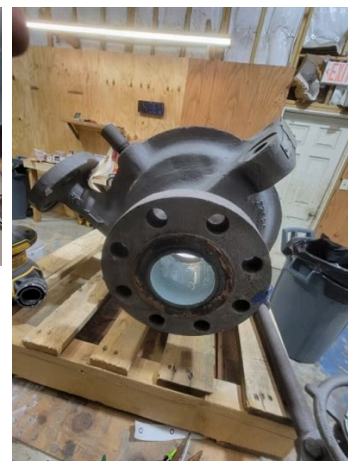
Close up on patched area with coating over top.
