Repair and Protection of the Intermediate & Tail Shaft of the BELEM Ship.

Industry: *Marine*
Application: *SOS-Ships and Offshore Structures*
Substrate: *Carbon steel*
Products: *Belzona 1111 (Super Metal), Belzona 5821*

Customer Location: *Saint Nazaire*
Application Date: *February 2023*

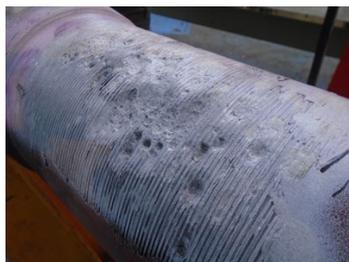
The propeller shaft showed heavy wear due to seawater corrosion.

The propeller shaft severely damaged by corrosion.

After grit-blasting and salt washing, reconstruction of the damaged propeller shaft was carried out using Belzona 1111. Two coats of Belzona 5821 were then applied to protect the shaft from future seawater corrosion. The application was carried out in accordance with Belzona System Leaflet SOS-06.

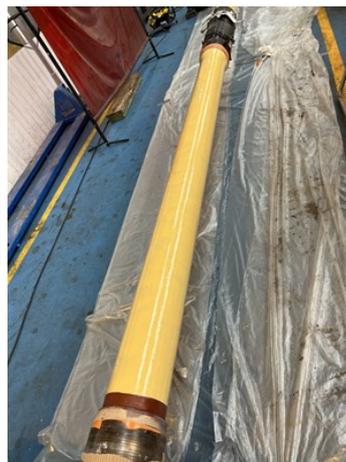
The propeller shaft was rebuilt using Belzona 1111 and the first coat of Belzona 5821.

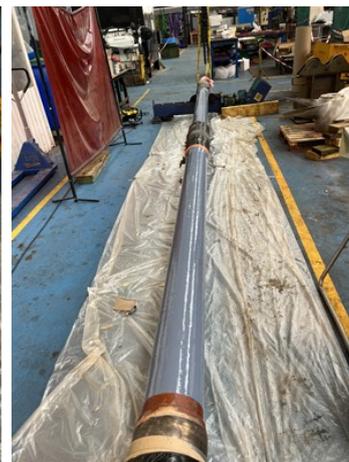
Final application with the second coat of Belzona 5821 applied.
