# Repair and Protection of the Intermediate & Tail Shaft of the BELEM Ship.

ID: 9050

Customer Location: *Saint Nazaire*  
Application Date: *February 2023*

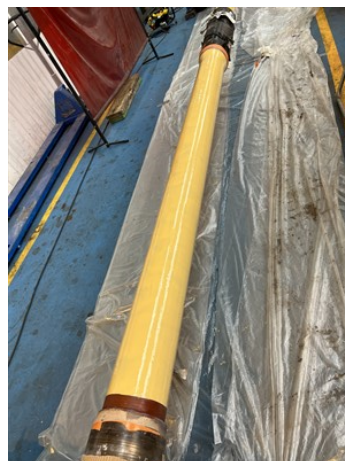
The propeller shaft was rebuilt using Belzona 1111 and the first coat of Belzona 5821.

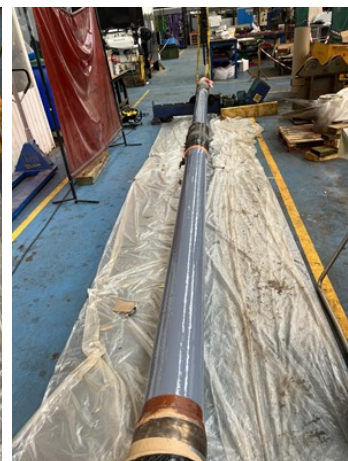
Final application with the second coat of Belzona 5821 applied.
