# Repair and Protection of the Intermediate & Tail Shaft of the BELEM Ship.

ID: 9050

Customer Location: *Saint Nazaire*  
Application Date: *February 2023*

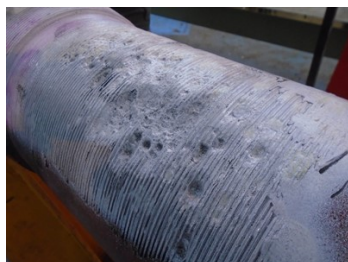
*The propeller shaft showed heavy wear due to seawater corrosion.*

The propeller shaft severely damaged by corrosion.

After grit-blasting and salt washing, reconstruction of the damaged propeller shaft was carried out using Belzona 1111. Two coats of Belzona 5821 were then applied to protect the shaft from future seawater corrosion. The application was carried out in accordance with Belzona System Leaflet SOS-06.

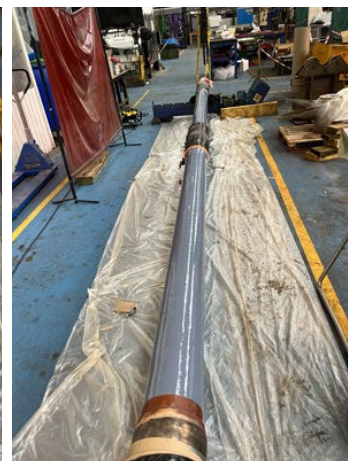
Final application with the second coat of Belzona 5821 applied.
