Belzona Repairs two Hydrocyclones within a Sugar Refinery using Alumina Tiles.

ID: 9051

Industry: Sugar Customer Location: Seine-et-Marne
 Application: VPF-Valves, Pipes and Fittings Application Date: February 2023
 Substrate: Cast Iron
 Products: Belzona 1391 (Ceramic HT), Belzona 1814, Belzona 9811

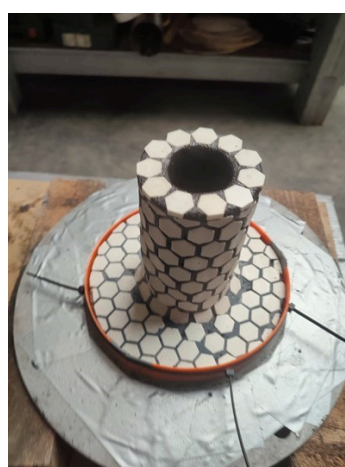
During the repair procedure.

The substrate was first prepared, followed by bonding the Belzona 9811 alumina tiles using Belzona 1391 (remaining stock). Once the tiles were glued in place, the interstices were grouted using Belzona 1814. The application was carried out in accordance with Belzona System Leaflet VPF-02.
