# Belzona Repairs two Hydrocyclones within a Sugar Refinery using Alumina Tiles.

ID: 9051

Industry: Sugar  
 Application: VPF-Valves, Pipes and Fittings  
 Substrate: Cast Iron  
 Products: Belzona 1391 (Ceramic HT), Belzona 1814, Belzona 9811

Customer Location: Seine-et-Marne  
 Application Date: February 2023

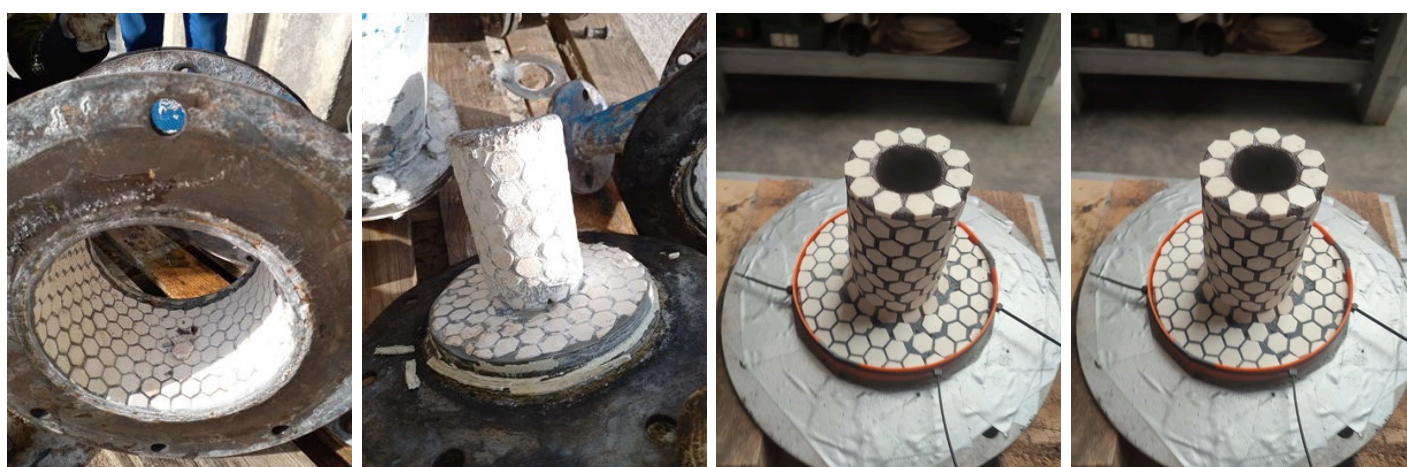
Two hydrocyclones were subjected to strong abrasion combined with a chemical attack (Milk of Lime;  $[Ca(OH)_2]$ ). After 6-years of operation, a refurbishment was necessary.

Current system after 6-years of service.

During the repair procedure.

After the refurbishing works.

The substrate was first prepared, followed by bonding the Belzona 9811 alumina tiles using Belzona 1391 (remaining stock). Once the tiles were glued in place, the interstices were grouted using Belzona 1814. The application was carried out in accordance with Belzona System Leaflet VPF-02.
