Belzona 5721 Repairs Cooling Tower Fan Blades Leading Edge

Industry: Power
Application: FBC-Fans, Blowers and Compressors

Customer Location: Wilsonville, AL
Application Date: April 2023

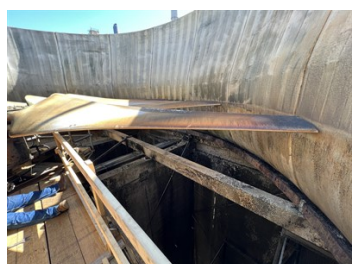
The customer had some questionable fan blades that were in need of attention. The leading edge has some light pitting and deteriorated from erosion and wear. They were looking to protect the current ones in service rather than purchasing new ones.

Before - In Service Pitted Blades

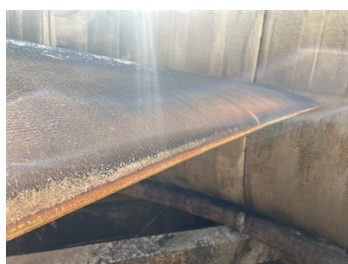
Before - Close up of Current Condition pitting/wear on the leading edge

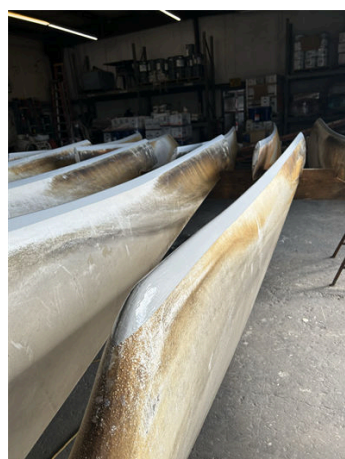
Completed View 1 4" Strip of Belzona 5721 Applied to Leading Edge

After pressure washing, we addressed any small pits along the leading edge and sanded down the area to coat a 4" strip of Belzona 5721 (designed for wind turbine blades) that ran the edge of the 11' blade.

Coated leading edge 2" on both sides of blades.

- Use sander for profile.
- Apply Belzona 2911 QD conditioner let cure.
- Apply 1st coat Belzona 5721 UV stable coating white let cure.
- Apply 2nd coat Belzona 5721 UV stable coating grey let cure.
- Blades to be wrapped in bubble wrap to protect leading edge for transport to facility.

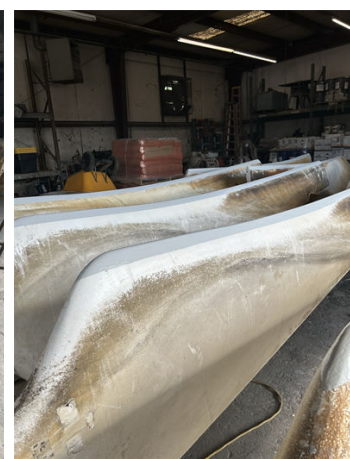
Completed View 2 - 4" Strip of Belzona 5721 Applied to Leading Edge
