Belzona 5721 Repairs Cooling Tower Fan Blades Leading Edge

ID: 9055

Industry: Power
Application: FBC-Fans, Blowers and Compressors

Customer Location: Wilsonville, AL
Application Date: April 2023

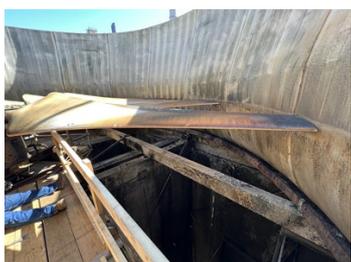
The customer had some questionable fan blades that were in need of attention. The leading edge has some light pitting and deteriorated from erosion and wear. They were looking to protect the current ones in service rather than purchasing new ones.

Before - In Service Pitted Blades

After pressure washing, we addressed any small pits along the leading edge and sanded down the area to coat a 4" strip of Belzona 5721 (designed for wind turbine blades) that ran the edge of the 11' blade.

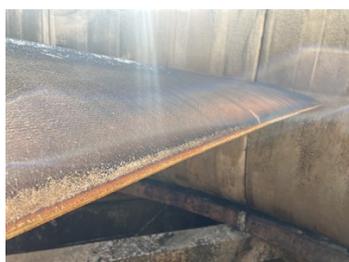
Before - Close up of Current Condition pitting/wear on the leading edge

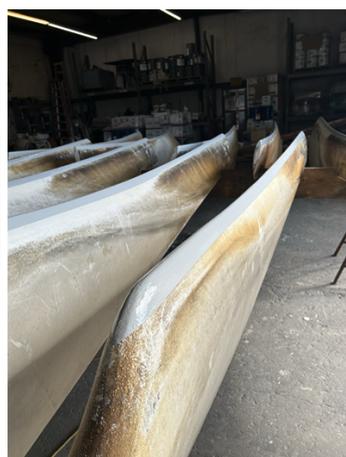
Completed View 1 4" Strip of Belzona 5721 Applied to Leading Edge

Coated leading edge 2" on both sides of blades.

- Use sander for profile.
- Apply Belzona 2911 QD conditioner let cure.
- Apply 1st coat Belzona 5721 UV stable coating white let cure.
- Apply 2nd coat Belzona 5721 UV stable coating grey let cure.
- Blades to be wrapped in bubble wrap to protect leading edge for transport to facility.

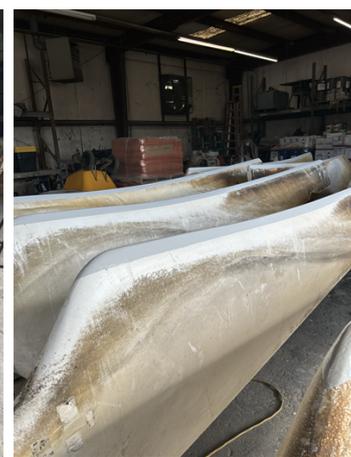
Completed View 2 - 4" Strip of Belzona 5721 Applied to Leading Edge
