Belzona repairs worn stairs in a school built in 1901

ID: 9056

Application: FPA-Floor Problem Areas

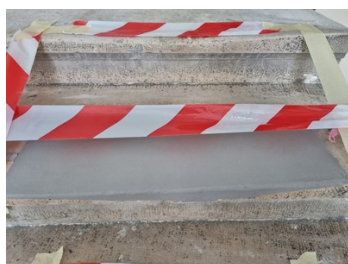
Loss of thickness on a stair due to 120 years of wear, represents a risk of falling and injury.

We installed a wooden support on front side of the stairs and then abraded the surface with electric grinders. Then we conditioned the surface with Belzona 4911 (using brush) and applied Belzona 4111 using a trowel. After full cure of Belzona 4111 we abraded surface once more and applied Belzona 4151 with addition of fine white dust in amount that produced color desired by customer.

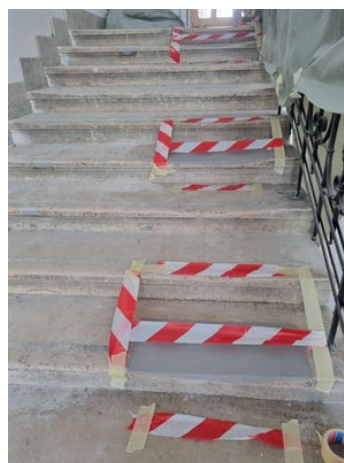
A stair rebuilt to its original level using Belzona 4111

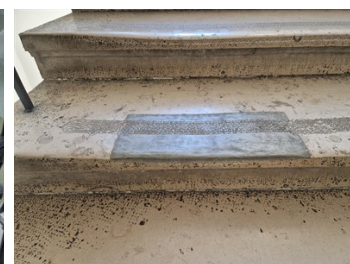
A view on one of staircases in the school with several stairs repaired.
