## Belzona repairs worn stairs in a school built in 1901

ID: 9056

Application: FPA-Floor Problem Areas

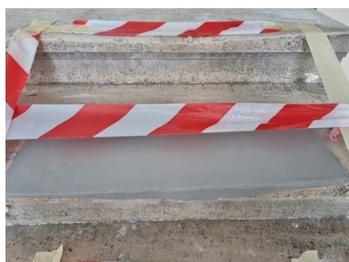
Loss of thickness on a stair due to 120 years of wear, represents a risk of falling and injury.

We installed a wooden support on front side of the stairs and then abraded the surface with electric grinders. Then we conditioned the surface with Belzona 4911 (using brush) and applied Belzona 4111 using a trowel. After full cure of Belzona 4111 we abraded surface once more and applied Belzona 4151 with addition of fine white dust in amount that produced color desired by customer.

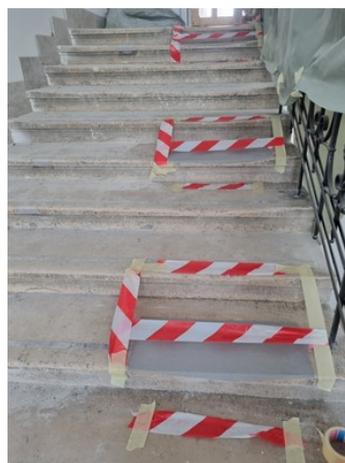
A stair rebuilt to its original level using Belzona 4111

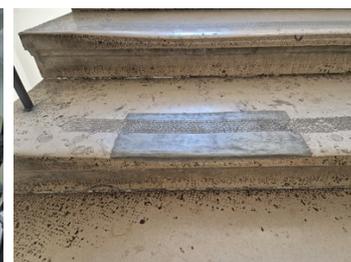
A view on one of staircases in the school with several stairs repaired.
