Belzona Helps to Refurbish Historical WWII USS Bowfin Submarine

ID: 9057

Industry: Marine
Application: SOS-Ships and Offshore Structures

Substrate: Carbon steel
Products: Belzona 1121 (Super XL-Metal)

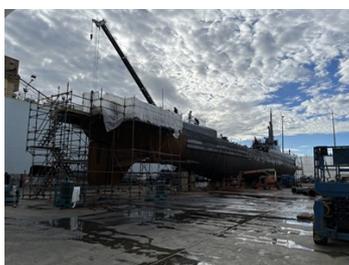
The USS Bowfin a Historical WWII Submarine had been situated in the Pearl Harbor Submarine Museum and Park since it was retired in 1971. After 20 years in the water since last dry dock visit it was finally brought back to dry dock for refurbishment. There was extensive and deep pitting of the submarine's hull down the waterline and had to be fixed/repaired during the dry dock refurbishment.

USS Bowfin on dry dock being refurbished.

Hull area was blasted to SSPC SP-10 cleanliness and a 3 mil profile. The repair area was clean with the proper solvent cleaner after blast. Belzona 1121 was applied in the critical pitted area that was identified. After the 1121 was fully cured the hull was painted with the specified product.

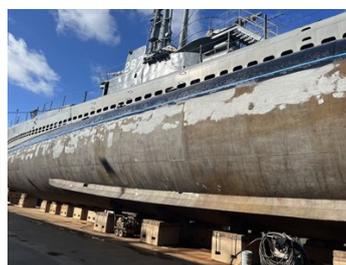
All of the pitted area filled with Belzona 1121 around the hull of the submarine.
