BELZONA REBUILDS WEAR RING SEATS

ID: 906

Industry: Power
Application: CEP-Centrifugal Pumps
Substrate: Cast Iron
Products: Belzona® 1311 (Ceramic R-Metal)

Customer Location: Power plant - Tulsa, Oklahoma, USA
Application Date: October 2007

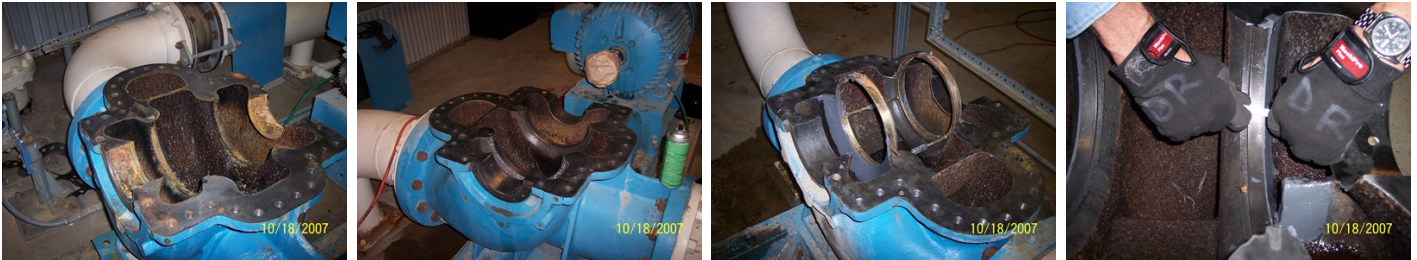
Photograph Descriptions

Problem
Severe erosion corrosion

* Pump to be rebuilt , * Surface being prepared , * Wear rings used as formers for Belzona® 1311 rebuild , * Scrapers used to complete application ,

Application carried out in accordance with Belzona System Leaflet CEP-2. Wear rings used as formers. After curing excess Belzona® 1311 removed with scrapers.

Belzona repair carried out quickly, postponed pump replacement, and improved pump efficiency.
