# Belzona protects cooling water pump's impeller from cavitation in nuclear power plant

ID: 9060

Industry: Power  
Application: CEP-Centrifugal Pumps  
Substrate: Stainless-steel  
Products: Belzona 1111 (Super Metal), Belzona 1341 (Supermetalglide), Belzona 2141 (ACR-Fluid Elastomer)

Customer Location: Krško  
Application Date:

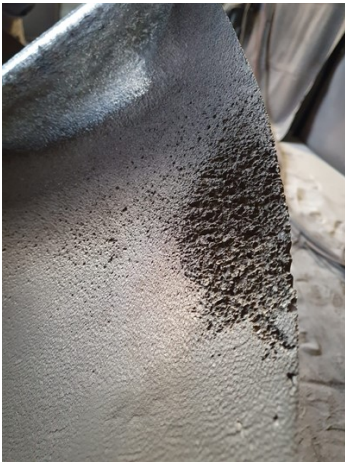
At the end of planed overhaul, severe cavitation was detected on one of the main cooling pumps.

Cavitation damage
