Debarker Ring protection saving lumber mill thousands

Application: *VPF-Valves, Pipes and Fittings*

Substrate: *Carbon steel*

Products: *Belzona 1311 (Ceramic R-Metal), Belzona 1321 (Ceramic S-Metal)*

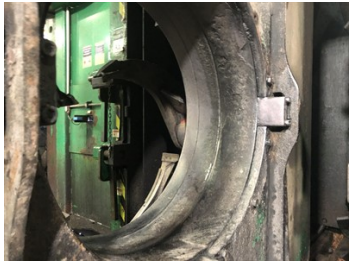
Corrosion was occurring from the salt water that enters the lumber mill from the ocean. This jeopardizes the bearing inside the ring that has a replacement cost of \$35,000.00. Protection was needing to prolong the service life of the machinery

Condition of Debarker ring

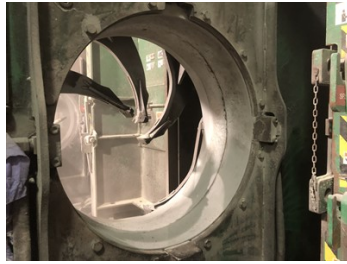
After sandblasting

Initial sandblasting was required for sufficient surface preparation. All Belzona material were mixed applied by hand to specification. Heat was added to assist in the curing process. The customer was thrilled with the result.

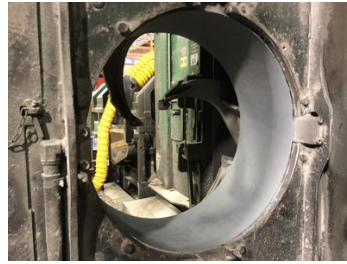
Resurfacing with Belzona 1311
