Debarker Ring protection saving lumber mill thousands

ID: 9063

Products: Belzona 1311 (Ceramic R-Metal), Belzona 1321 (Ceramic S-Metal)

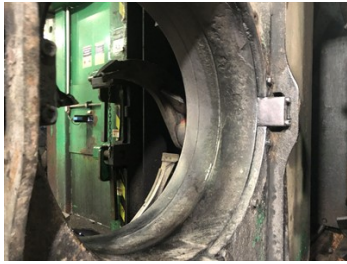
Corrosion was occurring from the salt water that enters the lumber mill from the ocean. This jeopardizes the bearing inside the ring that has a replacement cost of \$35,000.00. Protection was needing to prolong the service life of the machinery

Condition of Debarker ring
