Debarker Ring protection saving lumber mill thousands

ID: 9063

Application: *VPF-Valves, Pipes and Fittings*

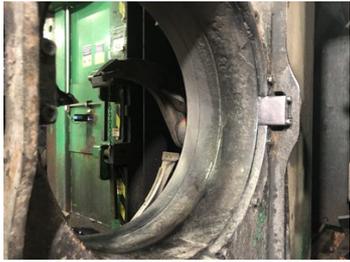
Corrosion was occurring from the salt water that enters the lumber mill from the ocean. This jeopardizes the bearing inside the ring that has a replacement cost of \$35,000.00. Protection was needing to prolong the service life of the machinery

Condition of Debarker ring

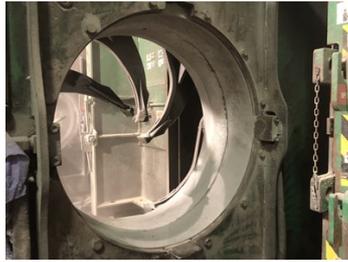
After sandblasting

Initial sandblasting was required for sufficient surface preparation. All Belzona material were mixed applied by hand to specification. Heat was added to assist in the curing process. The customer was thrilled with the result.

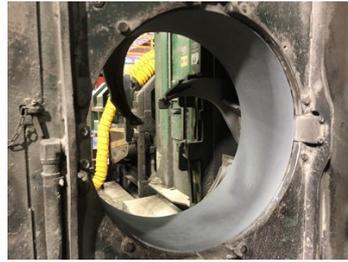
Resurfacing with Belzona 1311

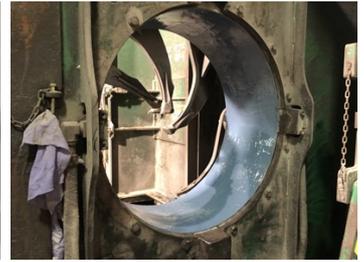
Coating of Belzona 1321
