Belzona seals the expansion joint at the entrance to the underground garage of a large residential building

ID: 9066

Customer Location: Zagreb, Croatia

Application Date: October 2022

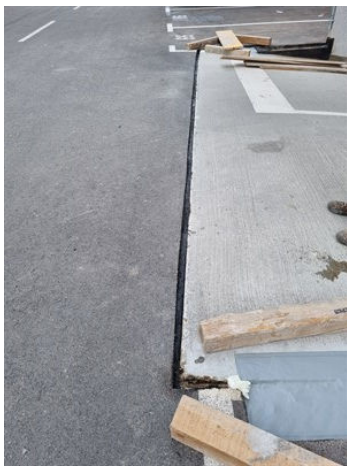
Expansion joint cleaned and conditioned with Belzona 4911

We grinded away asphalt and concrete until we reached the existing insulation beneath them. Then we thoroughly cleaned the surface and applied Belzona 4911 Conditioner. Right after that, we applied Belzona 4511 on both sides (downward slopes) and Belzona 4521 on the horizontal section. Then we protected the area of application with thick planks, so tenants could use the underground garage.

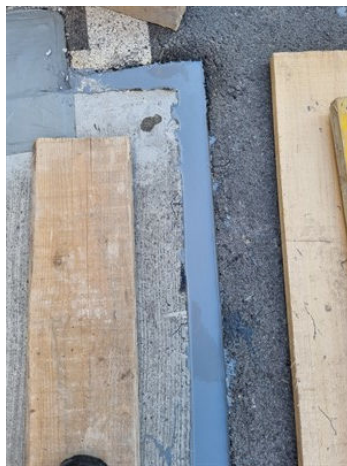
Belzona 4511 applied on sides and Belzona 4521 applied on the horizontal section of the joint.

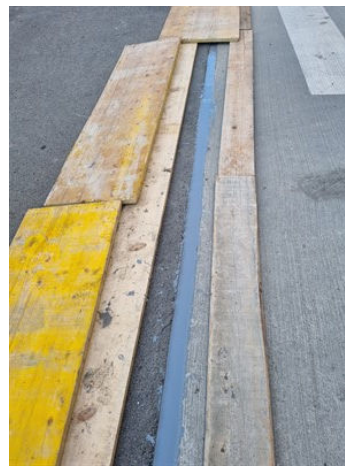
Installing thick planks after the application in order to enable traffic. We used those planks also during the application.

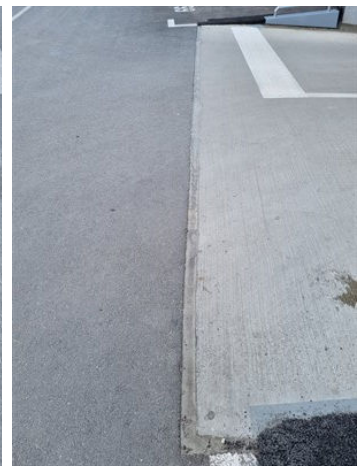
Situation after 7 months, with Belzona sealants still intact and in perfect condition.
