Belzona seals the expansion joint at the entrance to the underground garage of a large residential building

ID: 9066

Application: FPA-Floor Problem Areas

Application Date: October 2022

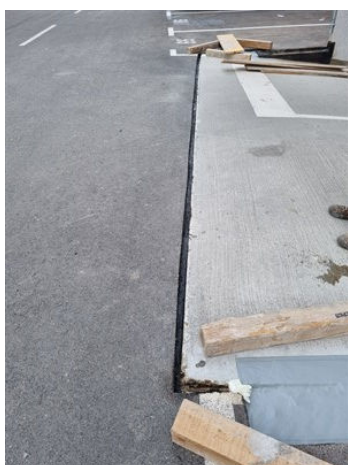
Expansion joint cleaned and conditioned with Belzona 4911

We grinded away asphalt and concrete until we reached the existing insulation beneath them. Then we thoroughly cleaned the surface and applied Belzona 4911 Conditioner. Right after that, we applied Belzona 4511 on both sides (downward slopes) and Belzona 4521 on the horizontal section. Then we protected the area of application with thick planks, so tenants could use the underground garage.

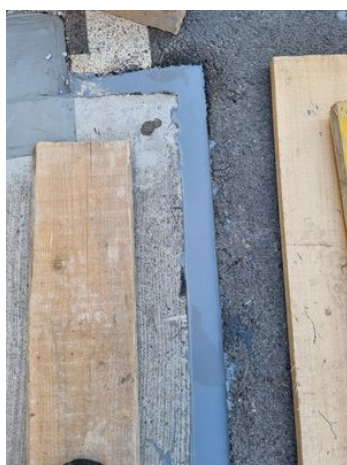
Belzona 4511 applied on sides and Belzona 4521 applied on the horizontal section of the joint.

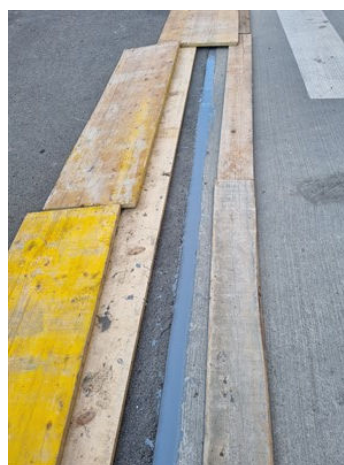
Installing thick planks after the application in order to enable traffic. We used those planks also during the application.

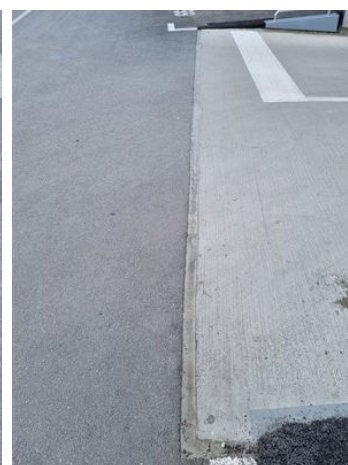
Situation after 7 months, with Belzona sealants still intact and in perfect condition.
