Belzona Patches Heated Oil Jacket

ID: 9074

Application: TCC-Tanks and Chemical Containment Areas

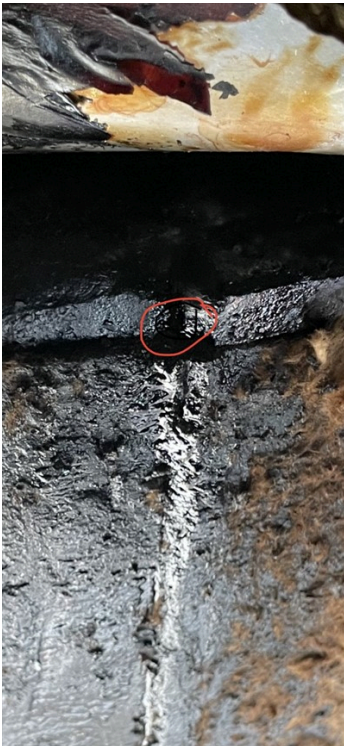
Customer had a pinhole leak in corner of heated oil jacket. It was not possible to drain this jacket as it was tied into the other 73 tanks.

Pinhole leak in oil jacket

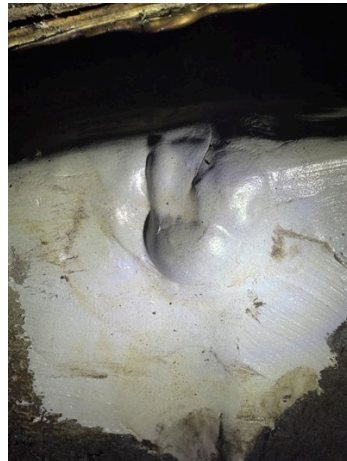
Live leak plugged with Belzona 9611 and sealed with Belzona 1221

Belzona 9611 was used to plug the hole with Belzona 1221 used as reinforcement. Once that was cured and leak was stopped, Belzona 1511/9341 was used to create a patch over the top of the leak for rebuild/reinforcement.

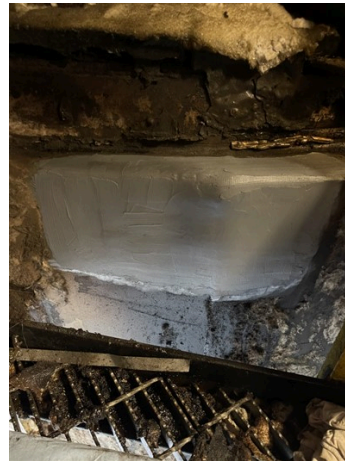
Belzona 1511 used to rebuild the area
