Leak Repair at Pickling Line

ID: 9080

Industry: Steel & Metal Processing
Application: TCC-Tanks and Chemical Containment Areas

Products: Belzona 1511 (Super HT-Metal), Belzona 1593, Belzona 9111 (Cleaner Degreaser)

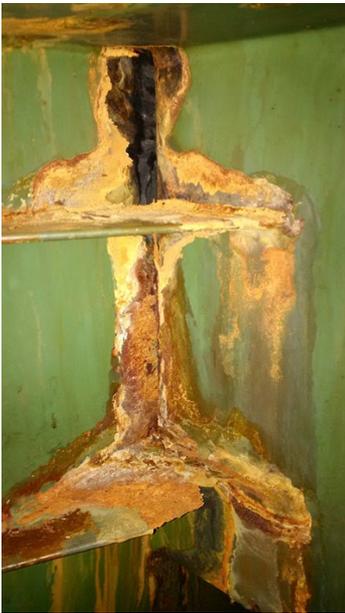
Hydrochloric acid tank in a Pickle line was suffering from chemical attack and developed a leak. They needed a product that had excellent chemical resistance against Hydrochloric acid at high concentrations to stop this leak and protect the outside of the tank.

The substrate chemically attacked from the acid

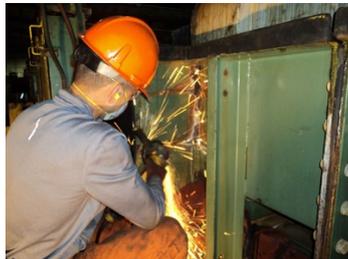
Surface preparation with a grinder to bare metal

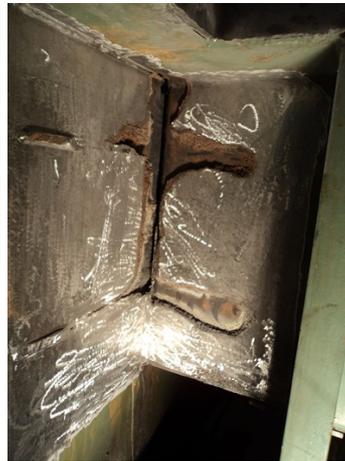
Cleaned substrate before product application

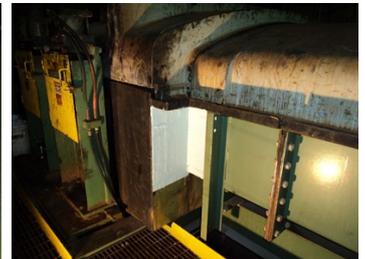
Finished application with Belzona 1593 as top coat

Belzona 1511 was used to bond the plate securely along its perimeter, while Belzona 1593 was injected to fill the void and ensure optimal protection against the chemical exposure. To provide comprehensive protection, the top of the plate and its surrounding

areas were coated with a layer of Belzona 1593, further enhancing the durability and longevity of the repair.
