Belzona Forms Gasket Surface on over 50 year old Boiler

ID: 9081

Application: GSS-Gaskets, Seals and Shims

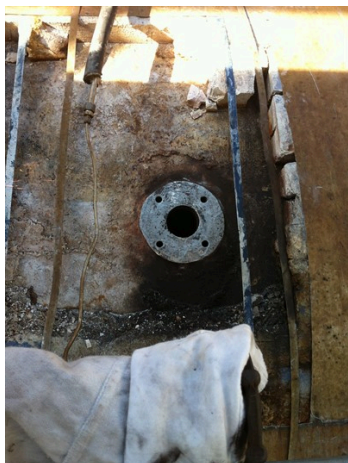
The gasket surface on the nozzle of a boiler was heavily pitted not allowing them to achieve a seal.

Gasket damage

Belzona 1111 was used in conjunction with a former to restore the gasket surface to the boiler nozzle.

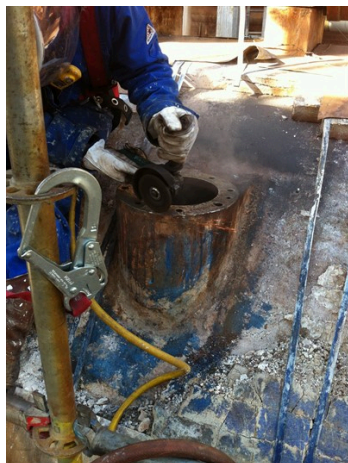
Surfaces preparation

Hand tools were used for preparation of the surface. Belzona Release Agent was applied to the former to allow removal.

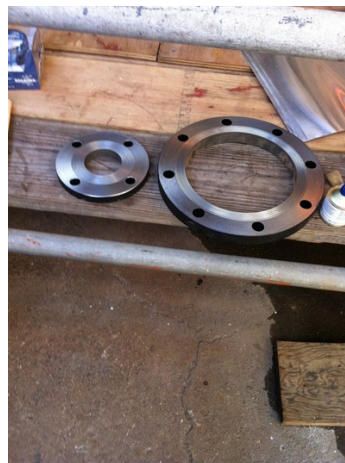
Formers used

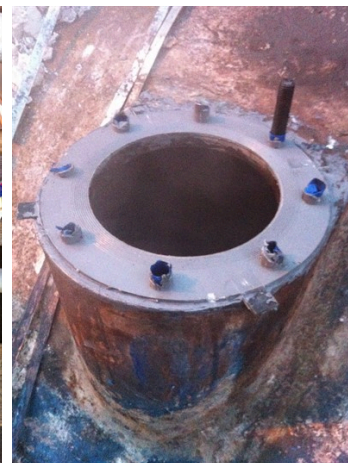
Application completed
