Belzona Protects Acid Barge Drip Pans

ID: 9082

Industry: *Marine*
Application: *TCC-Tanks and Chemical Containment Areas*

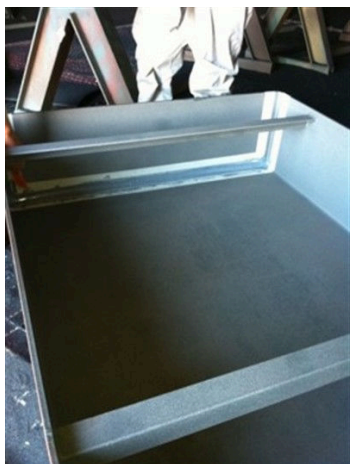
Customer was experiencing corrosion in their unlined drip pans.

Surface preparation drip pan 1 Surface preparation drip pan 2 Product application process Application completed.

Client was replacing their acid drip pans every few years. Acid remnants would sit in the pans exposed to atmosphere and corrode the bottom.

Grit basted the interior surface. Applied 4301 to fillet the weld seams. Then applied 4311 to the entire interior.
