Belzona Repairs Damaged Floor in Sterile Cartwashing Area in Local Hospital

Industry: Buildings & Structures
Application: FPA-Floor Problem Areas
Substrate: Concrete
Products: Belzona 1121 (Super XL-Metal), Belzona 1321 (Ceramic S-Metal), Belzona 4311 (Magma CR1), Belzona 4911 (Magma TX Conditioner)

Customer Location: High Point, North Carolina
Application Date: April 2023

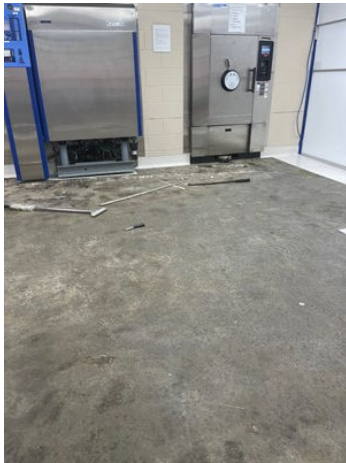
Vinyl Flooring Removed

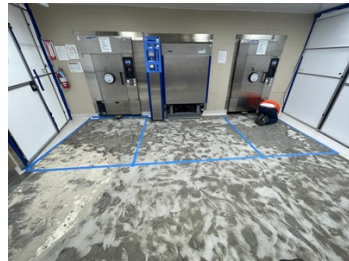
Floor area grinded

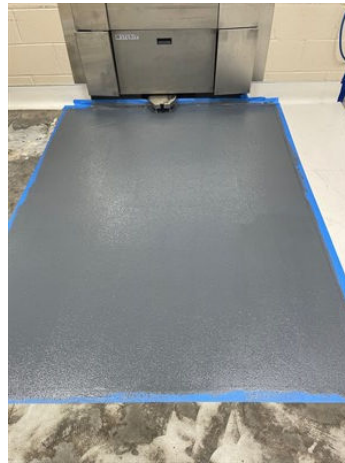
Belzona 1321 applied in front of Cartwash units

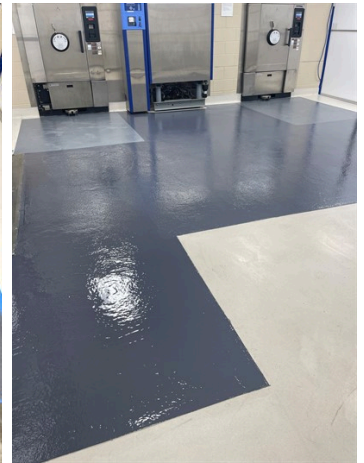
Belzona 4311 applied to rest of the area
