# Belzona Repairs Damaged Floor in Sterile Cartwashing Area in Local Hospital

ID: 9087

Customer Location: High Point, North Carolina  
Application Date: April 2023

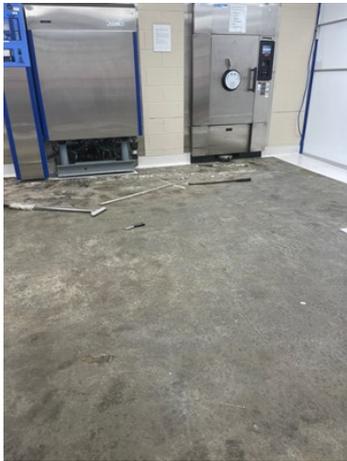
The high heat from the stainless carts being washed was melting the vinyl floor outside the washing units. The hospital had been written up many times during inspections and needed a solution for the floors near the washing units. They also needed something to withstand the steam temps and chemicals being used. The repair needed to be fast cure in nature as well since limited down time was available.

Vinyl Flooring Removed

Arrived at hospital Saturday morning at 8 aM. We taped off and cut out existing vinyl flooring. We then grinded entire floor with Hepa filter concrete grinder. After cleaning the floor we repaired uneven areas with Belzona 1121. We taped off Cart entrances and applied two coats of Belzona 1321. Came back Sunday morning and taped off rest of area, applied one coat Belzona 4911, and applied two coats of Belzona 4311. Application finished at 12 noon and Hospital crew came in later in evening to reassemble the room. Area put back to use Monday morning.

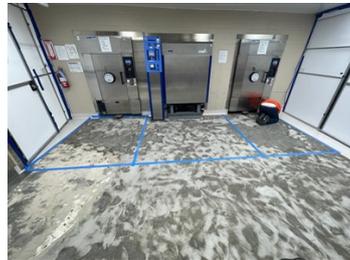
Floor area grinded

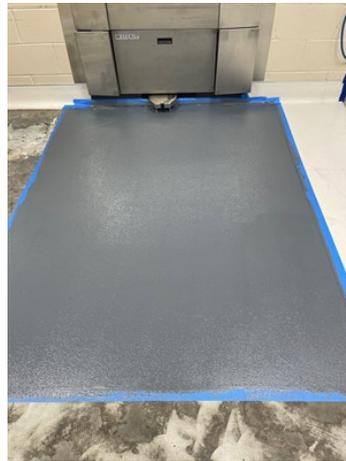
Belzona 1321 applied in front of Cartwash units

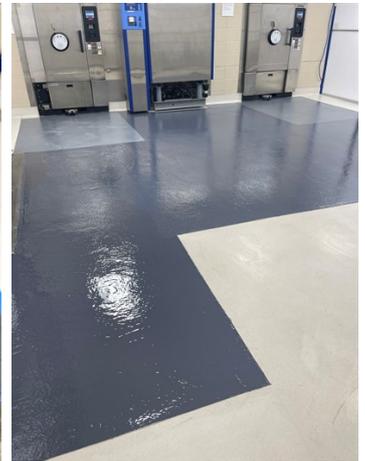
Belzona 4311 applied to rest of the area
