BELZONA RESTORES KITCHEN WASHROOM FLOOR

Customer Location: Hospital - Albuquerque, New Mexico, USA

Application: FPA-Floor Problem Areas

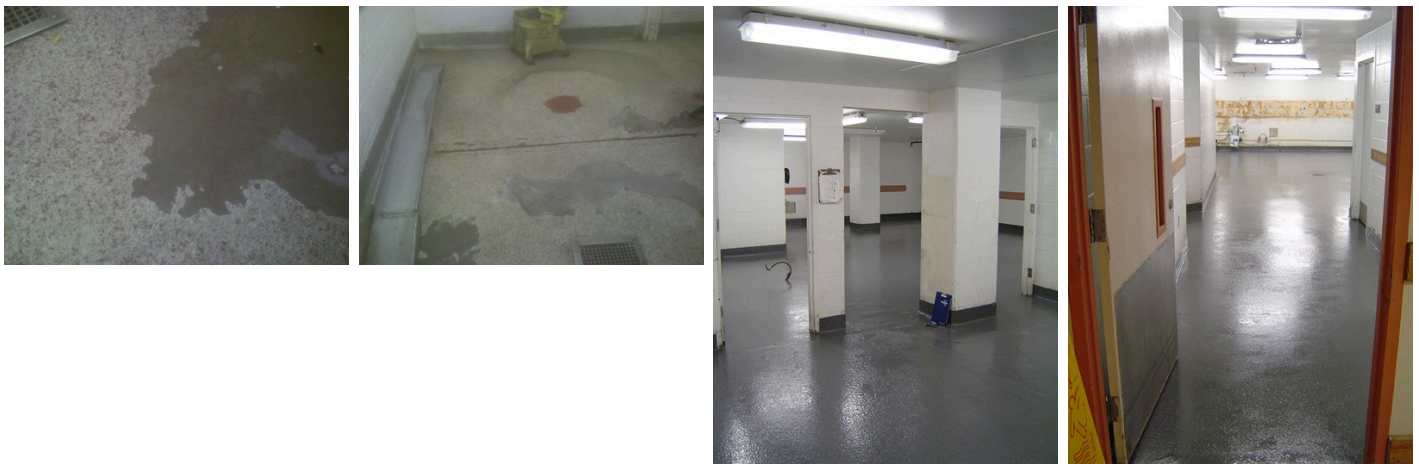
Photograph Descriptions

The terrazzo floor had degraded from constant cleaning and contact with cleaning solutions.

* Close-up of original damaged floor , * Heavy damage in washdown room , * Finished floor where washing machine goes , * Finished floor from outside hallway ,

The application was carried out in accordance with Belzona Know-How System Leaflet FPA-1. Belzona® 5231 was applied and extra grit broadcast on top.
