BELZONA RESTORES KITCHEN WASHROOM FLOOR

ID: 909

Customer Location: *Hospital - Albuquerque, New Mexico, USA*

Hospital kitchen washroom floor

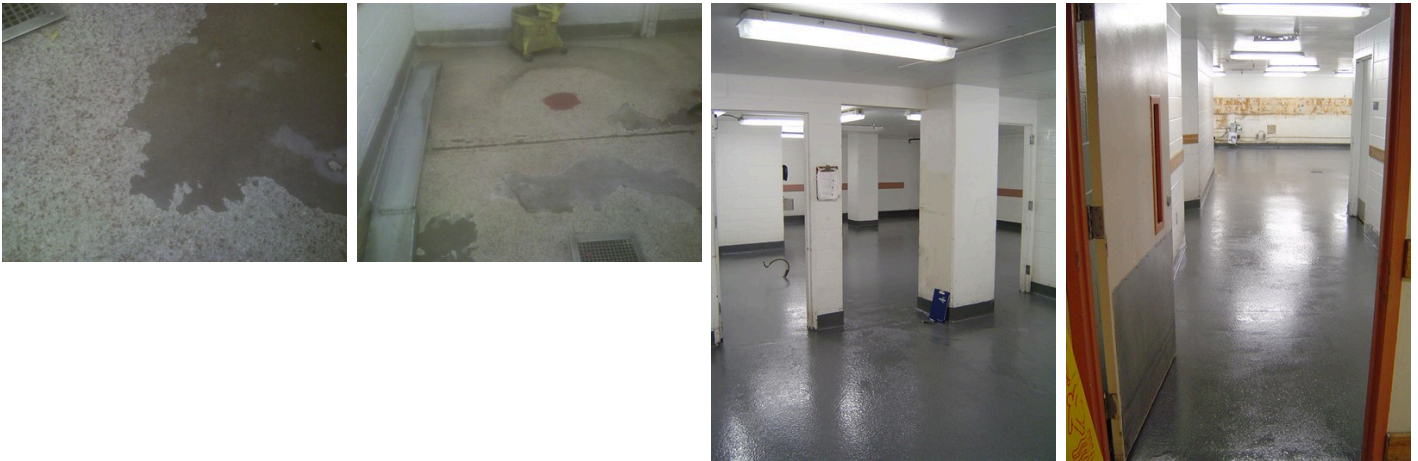
Photograph Descriptions

The terrazzo floor had degraded from constant cleaning and contact with cleaning solutions.

* Close-up of original damaged floor , * Heavy damage in washdown room , * Finished floor where washing machine goes , * Finished floor from outside hallway ,

The application was carried out in accordance with Belzona Know-How System Leaflet FPA-1. Belzona® 5231 was applied and extra grit broadcast on top.
