BELZONA REPAIR AND PROTECTION OF PIG LAUNCHERS

Customer Location: Offshore Gas Producer
Application Date: August 1994

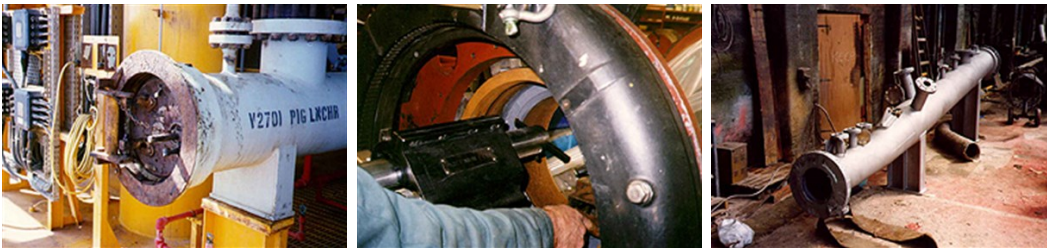
Photograph Descriptions

Crevice corrosion had caused pitting on the existing seal faces of pig launcher. New receivers for "Intelligent Pigs" required an impact/abrasion and corrosion resistant lining.

- * Existing pig launcher showing seal area ,
- * On-site machining of Belzona® 1111 underway ,
- * Application of Belzona® 1321 to a new launcher ,

Seal faces were rebuilt in accordance with a modified version of Belzona® Know-How Leaflet VPF-1, and machined on-site to the required tolerances. New launcher receivers were coated with Belzona® 1321 in accordance with Belzona® Know-How Leaflet VPF-2.
