BELZONA LINING FOR HEAT EXCHANGER SUMP

ID: 911

Customer Location: Major Hospital, NE Scotland

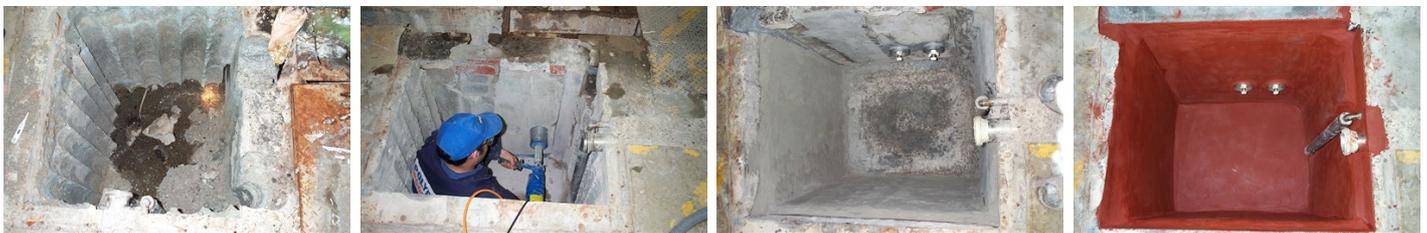
Photograph Descriptions

- * Sump drilled out ,
- * Cutting inlet and outlet channels to laundry drain ,
- * Walls rebuilt with Belzona® 4141 and paving slab installed ,
- * Sump screeded with Belzona® 4181 ,

Application carried out in accordance with modified version of System Leaflet TCC-9. First a new base to the sump was created using a paving slab. Belzona® 4141 was applied to fill the damage caused by the drill cores. Belzona® 4181 was then screeded over the entire surface to provide heat resistance.
