# BELZONA LINING FOR HEAT EXCHANGER SUMP

ID: 911

**Application:** TCC-Tanks and Chemical Containment Areas

**Customer Location:** Major Hospital, NE Scotland

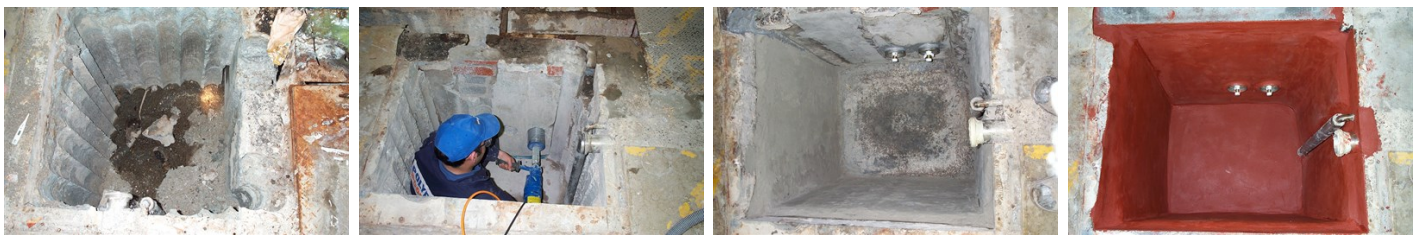
The system required a sump for the waste water to pass through, and having drilled it from solid concrete, it had to be lined and sealed.

- \* Sump drilled out ,
- \* Cutting inlet and outlet channels to laundry drain ,
- \* Walls rebuilt with Belzona® 4141 and paving slab installed ,
- \* Sump screeded with Belzona® 4181 ,

Application carried out in accordance with modified version of System Leaflet TCC-9. First a new base to the sump was created using a paving slab. Belzona® 4141 was applied to fill the damage caused by the drill cores. Belzona® 4181 was then screeded over the entire surface to provide heat resistance.
