Repair and Protection of Fixed Cone Free Valve for Hydropower Plant

Industry: Power

Customer Location: Miraflores, Antioquia, Colombia

Application: VPF-Valves, Pipes and Fittings

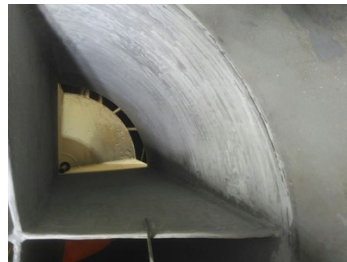
A Howell Bunger Free Discharge valve is commonly used for handling high flow rates from dams and reservoirs. The valve was inspected identifying severe corrosion, erosion, and wall thickness loss of the internal flow dividing walls; specifically at the fixed cone, valve's body, and shutter.

Damages to the valve's body.

- Surface preparation was performed by sandblasting the fixed cone, valve's body and shutter.
- The substrate's profile was measured, resulting in 3.4 mils.
- Belzona 1111 was applied to rebuild the worn areas.
- A first coat of Belzona 1341N (grey color) was applied to the fixed cone, valve's body, and shutter as per the Instructions for Use, and the wet film thickness was checked.
- A second coat of Belzona 1341N (blue color) was applied to the fixed cone, valve's body, and shutter as per the Instructions for Use, and the wet film thickness was checked.
