# Belzona 1818 Protects Shaft from Abrasion

ID: 9114

Application: SHM-Solids Handling Machinery

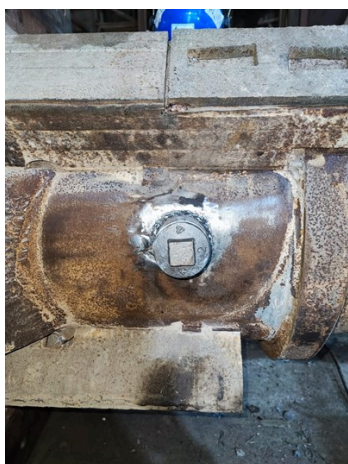
A separator shaft in a Cement Plant Raw Mill was suffering from severe fine particle abrasion from iron ore, shale and limestone at temperatures up to 100degC. The plant was on an unscheduled shutdown and needed the repair carried out quickly so that the mill could be out back into service

Area prepared using a power tool (MBX Bristle Blaster)

The areas where Belzona 1818 was to be applied were prepared using an MBX Bristle Blaster.

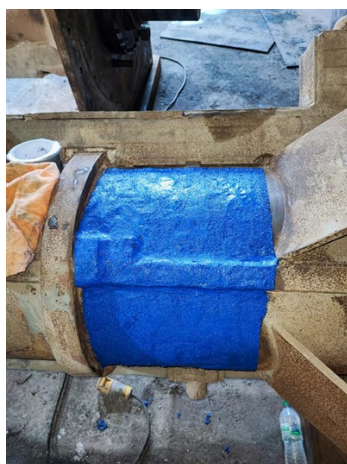
Belzona 1818 applied

The repair needed to be completed quickly. The rapid cure time of Belzona 1818 enabled the Mill to be put back into service in a matter of hours.

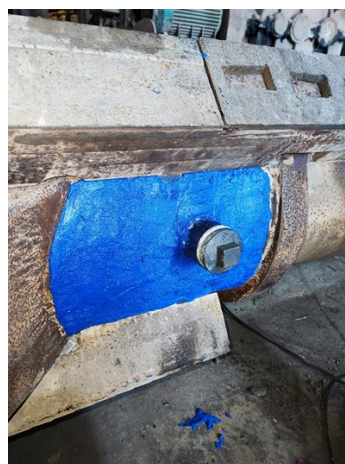
Belzona 1818 applied
