Belzona provides cavitation repair and protection for a large hydropower unit impeller

Customer Location: a large hydropower plant in Hunan, China

Application Date: March 2022

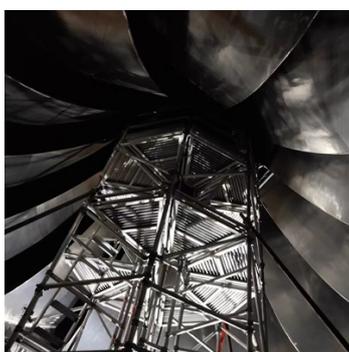
Cavitation occurs at the top of Francis impeller in a hydropower station unit

the image of affected impeller

The application was carried out in strict accordance with Belzona Know How leaflets FBC-1 and FBC-2. Belzona 1311 was used to repair the cavitation areas after grit blasting. Then, applied two coats of Belzona 1341 to improve fluid efficiency for the equipment. Finally, Belzona 2941 and Belzona 2141 were applied to protect the outer surface against cavitation and corrosion.

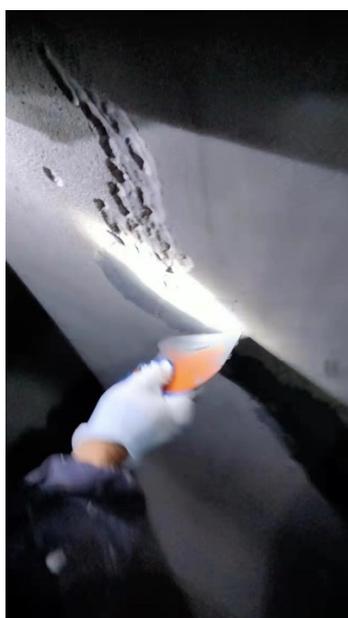
Pitting corrosion before repair

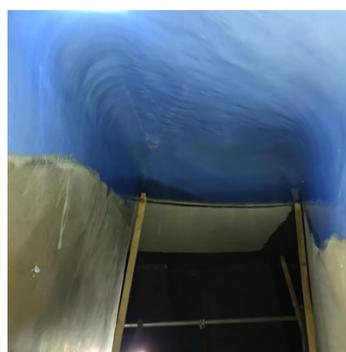
the surface after Belzona 1341 application
