Repair and Protection of Brine Water Vertical Pump

ID: 9126

Customer Location: Eastern Area
Application Date: May 2023

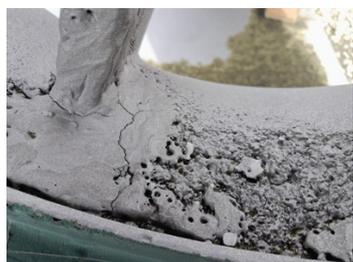
The pump casing was suffering from erosion and corrosion due to the salt water medium. The pump internal body was pitted and the external body was suffering from general corrosion. The customer requested a solution that would restore the pump's original profile and protect it for years to come.

Before application: internal pitting damage

The pump components were entirely blasted to reach the Belzona recommended 75 micron profile and salt tested to ensure that salt levels were minimal. Following surface preparation, Belzona 1111 was mixed according to the IFU to pit fill the damaged surfaces. After curing, the surface of Belzona 1111 was sweep blasted to receive protective coatings. Two coats of Belzona 1341 were applied internally and two coats of Belzona 5811 were applied externally at the recommended thicknesses indicated in the IFU.

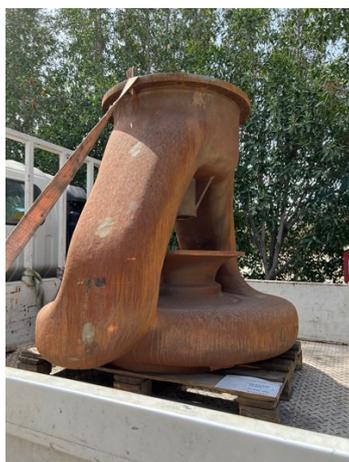
Before application: external corrosion

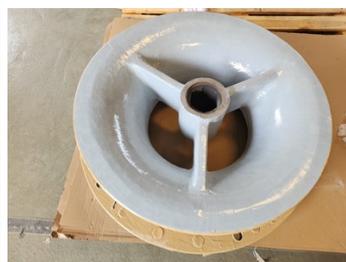
After application: internal surface coated for protection

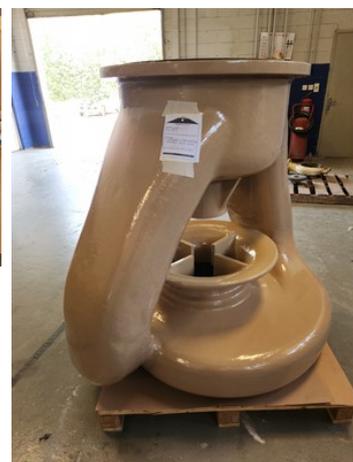
After application: external surface coated for protection
