Repair and Protection of Brine Water Vertical Pump

ID: 9126

Industry: Mining
Application: CEP-Centrifugal Pumps
Substrate: Cast Iron
Products: Belzona 1111 (Super Metal), Belzona 1341 (Supermetalgilde), Belzona 5811DW (DW Immersion Grade), Accessories, Belzona 9111 (Cleaner Degreaser), Salt-Away

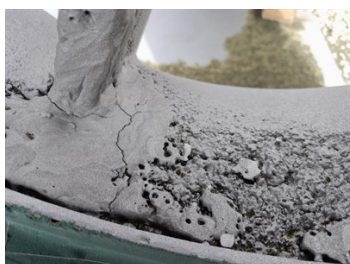
The pump casing was suffering from erosion and corrosion due to the salt water medium. The pump internal body was pitted and the external body was suffering from general corrosion. The customer requested a solution that would restore the pump's original profile and protect it for years to come.

Before application: internal pitting damage

The pump components were entirely blasted to reach the Belzona recommended 75 micron profile and salt tested to ensure that salt levels were minimal. Following surface preparation, Belzona 1111 was mixed according to the IFU to pit fill the damaged surfaces. After curing, the surface of Belzona 1111 was sweep blasted to receive protective coatings. Two coats of Belzona 1341 were applied internally and two coats of Belzona 5811 were applied externally at the recommended thicknesses indicated in the IFU.

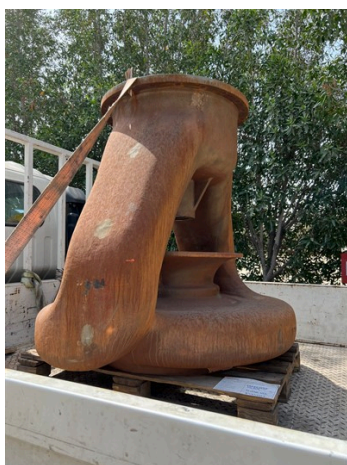
Before application: external corrosion

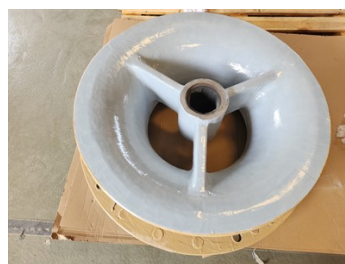
After application: internal surface coated for protection

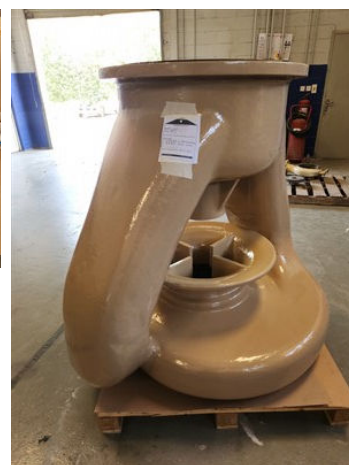
After application: external surface coated for protection
