Grouting and fairing of basalt tiles in a cement separator with Belzona

ID: 9129

Application: SHM-Solids Handling Machinery

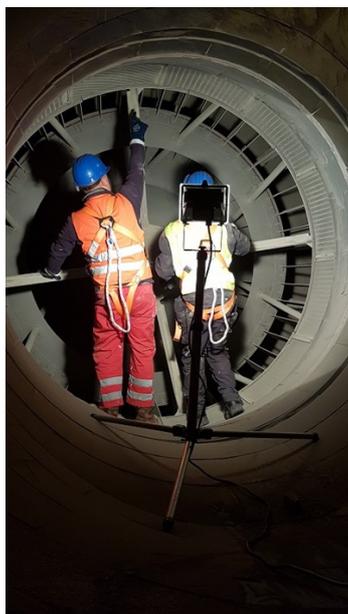
A separator in a cement plant is clad with basalt tiles, which are exposed to severe abrasion and they need to be protected from further deterioration.

Damaged basalt lining within the separator

A Humboldt-type separator operates in a cement plant 24/7. It is clad with basalt tiles, which are good and long-term solution, but eventually they get worn by severe abrasive influence of cement particles that are travelling through the separator in a turbulent flow. Customer allows a 5-day window to perform works inside the separator, during the annual turnaround and was looking for a solution that can solve the problem within selected timeframe.

Application was carried out in accordance with Belzona Know-How System Leaflet SHM-7. Surfaces were dedusted with vacuum cleaner, then abraded with grinders and cleaned with acetone. Belzona 1812 was applied to damaged areas of tiles and joints with Belzona application tools.

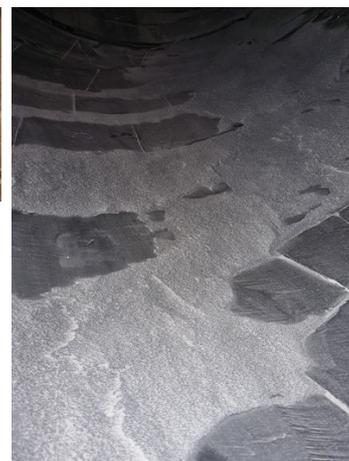
Belzona 1812 applied

Situation after 18 months – still OK

We came to the solution together with the customer, when the problem started to appear. We applied Belzona 1812 on a smaller section initially and customer was satisfied with the result, so now we are doing it every year since 2019. The only considered alternative was partial replacement of basalt tiles, but it is complicated and expensive, because there is no local supplier, it requires specialized works and there is also a time issue mentioned before. It is a good solution for the customer, because it "freezes" the actual situation and prevents further deterioration of basalt cladding. Belzona 1812 performs well and can be easily refurbished once it is worn.
