Belzona Protects a Coal Pulverizer Wheel Bracket

ID: 913

Customer Location: San Miguel Power Project Christine, TX
Application Date: November 2007

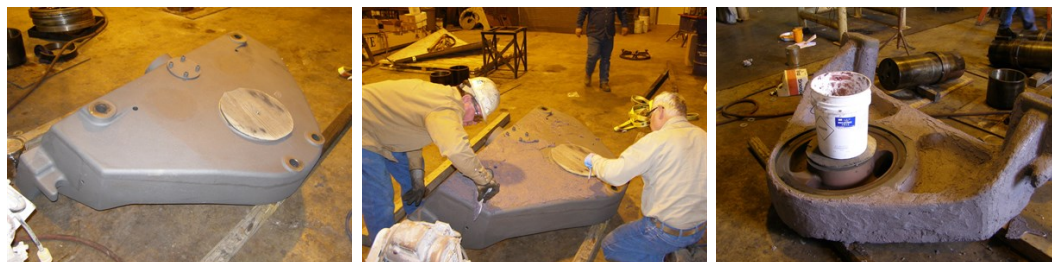
Photograph Descriptions

Over time the wheel bracket is wearing down leading to high replacement costs.

- * New pulverizer wheel bracket prepared for application ,
- * Belzona® 1812 being applied ,
- * Completed application ,

The application was carried out in accordance with a modified version of the Belzona Know-How System Leaflet VPF-2.

With a replacement cost of \$30,000 per bracket a protective coating was sought in order to prolong the life of the equipment. The customer had used several different products to address this problem and none had been effective. The need for expanded metal also made the previous applications much more time consuming leading to increased down time and man hours. The Belzona solution proved to be much easier and faster to apply than the alternatives. At a cost of \$4,200 per arm Belzona was able to save this plant thousands of dollars.
