# REPAIR, REBUILDING AND PROTECTION OF IMPELLER IMPELLER WITH BELZONA TECHNOLOGY

ID: 9132

Industry: Food & Drink  
Application: CEP-Centrifugal Pumps  
Substrate: Cast Iron  
Products: Belzona 1311 (Ceramic R-Metal), Belzona 1391T

Customer Location: SANTA CRUZ, BOLIVIA

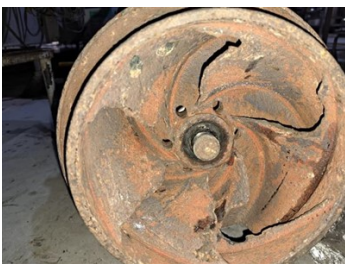
The impeller showed generalized wear, exhibiting the most damage on the vanes and on the trailing edges. This situation generated a loss of efficiency of the pump, the solution due to the damage of the part was to decide between rebuilding or replacing it.

Equipment to be repaired

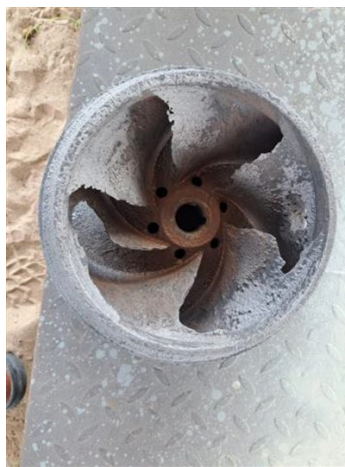
Sandblasted Impeller.

- Surface preparation with abrasive pressure blasting according to SSPC SP10, using sand as abrasive.
- Immersion of the Super Fox to completely remove the rust on the impeller surface.
- Rinsing with demineralized water.
- Degreasing of the surface with ethyl acetate.
- Measurement of environmental conditions prior to application.
- Measurement of reinforcement mesh to recover lost metal on blades.
- Recovery of lost metal with Belzona 1311 Ceramic R-Metal cold welding.
- Application of Belzona 1391T first layer coating
- Belzona 1391T second layer coating application

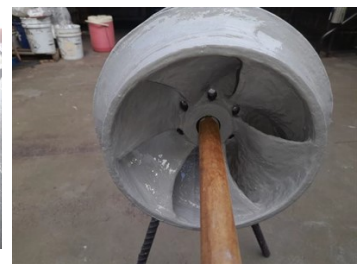
Completed Application.
