REPAIR, REBUILDING AND PROTECTION OF IMPELLER IMPELLER WITH BELZONA TECHNOLOGY

ID: 9132

Industry: *Food & Drink*
Application: *CEP-Centrifugal Pumps*
Substrate: *Cast Iron*
Products: *Belzona 1311 (Ceramic R-Metal), Belzona 1391T*

Customer Location: *SANTA CRUZ, BOLIVIA*
Application Date: *September 2022*

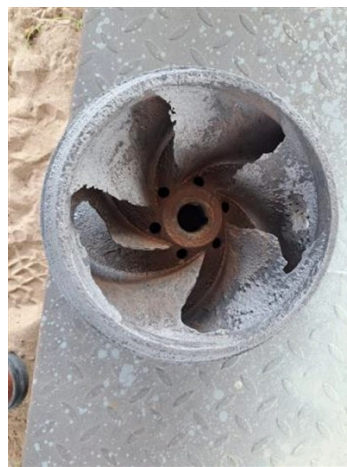
Sandblasted Impeller.

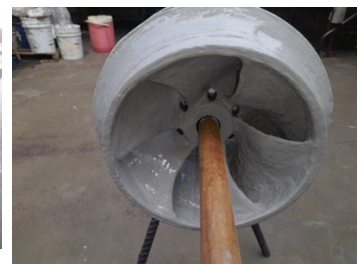
Completed Application.

- Surface preparation with abrasive pressure blasting according to SSPC SP10, using sand as abrasive.
- Immersion of the Super Fox to completely remove the rust on the impeller surface.
- Rinsing with demineralized water.
- Degreasing of the surface with ethyl acetate.
- Measurement of environmental conditions prior to application.
- Measurement of reinforcement mesh to recover lost metal on blades.
- Recovery of lost metal with Belzona 1311 Ceramic R-Metal cold welding.
- Application of Belzona 1391T first layer coating
- Belzona 1391T second layer coating application
