Belzona Saves Bow Thruster From Going Under

ID: 9143

Industry: Marine
Application: SOS-Ships and Offshore Structures

Substrate: Carbon steel
Products: Belzona 1311 (Ceramic R-Metal), Belzona 1321 (Ceramic S-Metal)

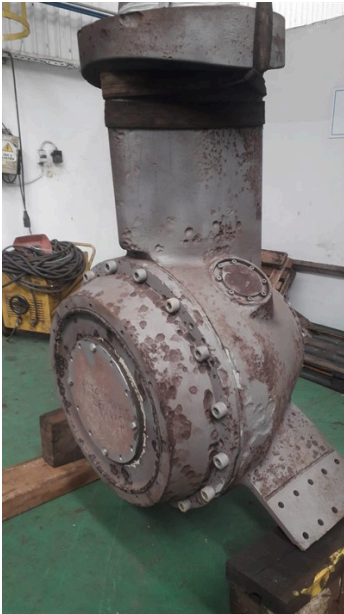
There was severe cavitation and corrosion damage on the surface of this bow thruster

Before Application (showing the cavitation damaged areas)

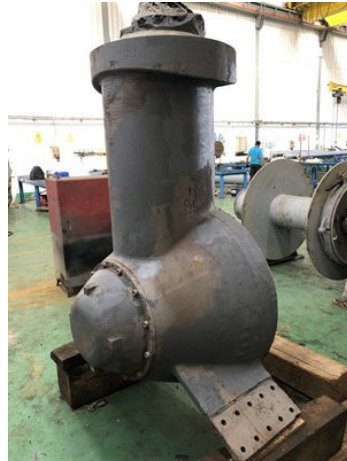
Belzona 1311 Applied for Repair

The surface of the bow thruster was first washed down with Belzona 9111 (Cleaner Degreaser) to remove all the dirt, grease and other surface contaminants before being grit blasted. Then Belzona 1311 (Ceramic-R-Metal) was used to repair the bow thruster, before adding a final coats of Belzona 1321 (Ceramic-S-Metal) to protect the equipment from further damage.

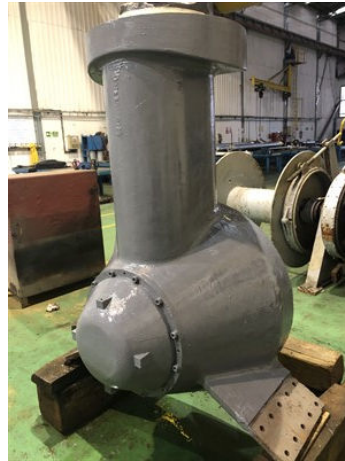
Belzona 1321 First Layer Coating Applied

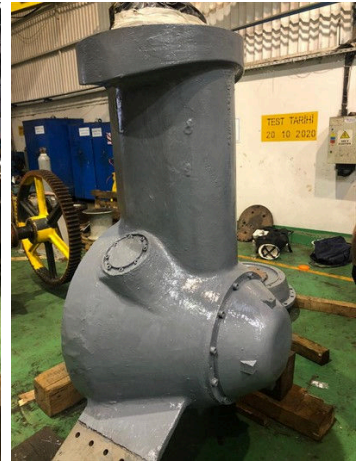
Belzona 1321 Second Layer Coating Applied
