BELZONA RELIEF VALVE REPAIR

Customer Location: Hydro Electric Generating Station -
Scotland

Application: MPT-Mechanical Power Transmission

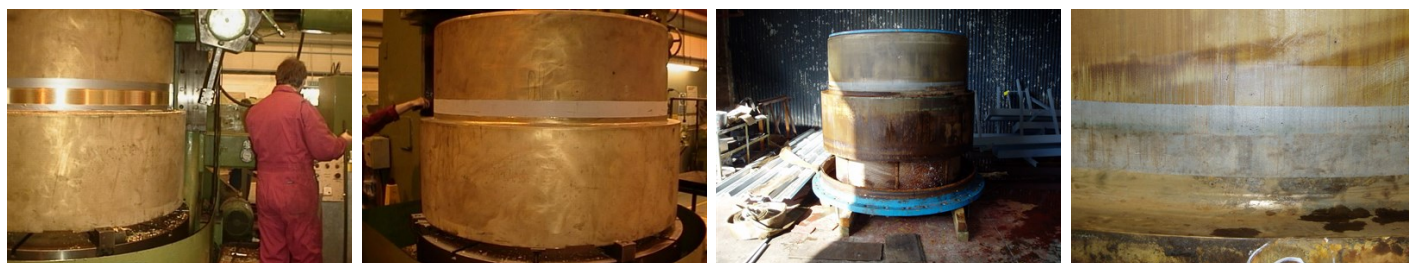
Photograph Descriptions

Previous attempts to weld similar equipment had resulted in the brass piston distorting and so an alternative method for repair was sought.

- * Piston being machined out. ,
- * Belzona® 1111 machined to tolerance. ,
- * Valve in for overhaul in 2007. This had nothing to do with the original Belzona repair. ,
- * Belzona in good condition and was returned to service with no work required after passing offsite hydrostatic testing and onsite commissioning. ,

The sealing surface on the pressure relief valve had suffered damage and water was passing causing the valve not function properly.

Application was carried out in accordance with the Belzona Know-How System Leaflet MPT-1. Damaged area was machined out, filled with Belzona® 1111 then machined to tolerance.

confirming Belzona repair in good condition and suitable for return to service after already completing 9 years service.
