External Rebuilding and Protection with Belzona

ID: 9155

Industry: Chemical & Petrochemical
Application: VPF-Valves, Pipes and Fittings
Substrate: Carbon steel
Products: Belzona 1161 (Super UW-Metal)

Customer Location: Cartagena/ Colombia
Application Date: October 2016

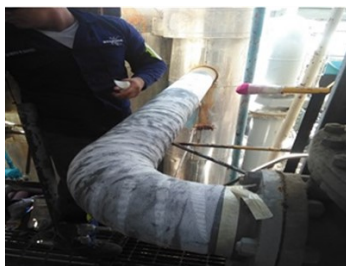
First layer of Belzona 1161 and reinforcement mesh.

The surface of the tube was prepared with a steel brush and sandpaper.

Initially the product was impregnated with a short bristle brush on the substrate, then with the applicator was given the desired thickness and a good finish.

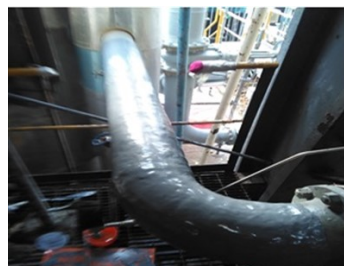
Work completed.

By rebuilding the surface with Belzona 1161, we stop the corrosion, recovered the surface and avoid the replacement of the valve section.
