# External Rebuilding and Protection with Belzona

ID: 9155

Industry: Chemical & Petrochemical  
Application: VPF-Valves, Pipes and Fittings  
Substrate: Carbon steel  
Products: Belzona 1161 (Super UW-Metal)

Customer Location: Cartagena/ Colombia  
Application Date: October 2016

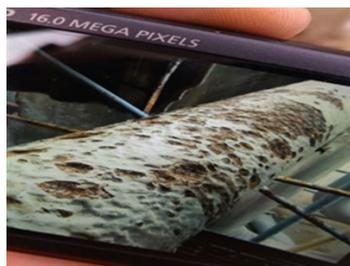
Severe corrosion on the outside of the 6" inch pipe, pitting is evident.

Pitting on pipe

The surface of the tube was prepared with a steel brush and sandpaper.

Initially the product was impregnated with a short bristle brush on the substrate, then with the applicator was given the desired thickness and a good finish.

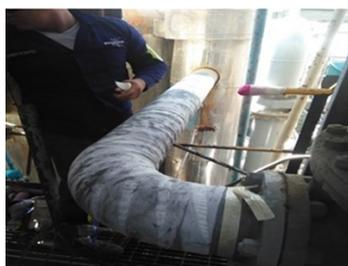
First layer of Belzona 1161 and reinforcement mesh.

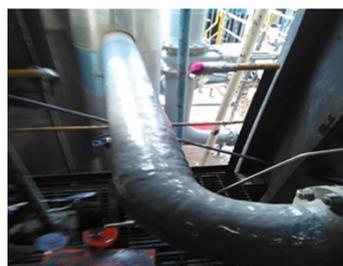
Work completed.

By rebuilding the surface with Belzona 1161, we stop the corrosion, recovered the surface and avoid the replacement of the valve section.
