Cold repairs to remedy the damages caused by welding

ID: 9165

Industry: Steel & Metal Processing
Application: TCC-Tanks and Chemical Containment Areas
Substrate: Carbon steel
Products: Belzona 1391T, Belzona 1511 (Super HT-Metal)

Customer Location: Germany
Application Date: October 2023

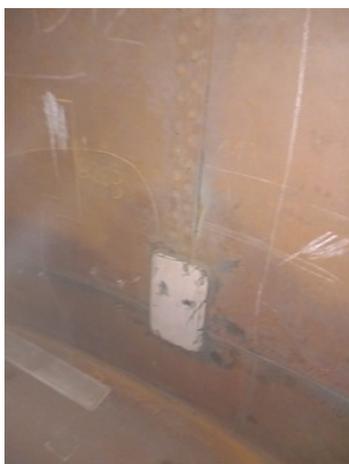
Small metal plate welded on the tank

Belzona 1511 was required to create a taper between the welded plates and the existing tank structure, before being overcoated using Belzona 1391T. The small circular plates were used by the contractor to plug holes where they pour a low cost mortar to fill the void.

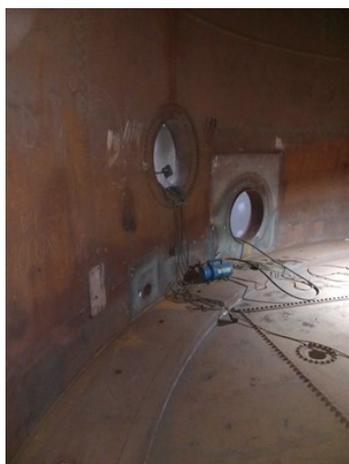
General View of the tank

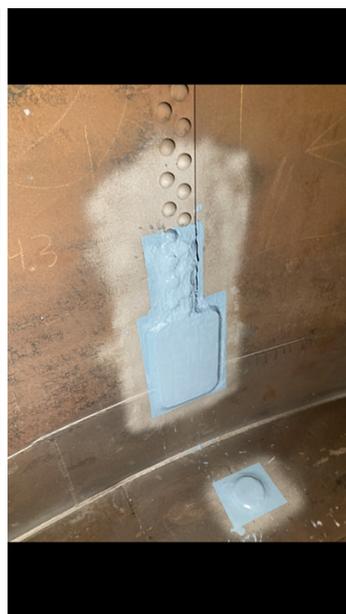
Localised repair

Around the riveted sections, Belzona 1511 was used in conjunction with the reinforcing mesh Belzona 9341, before overcoating using Belzona 1391T.

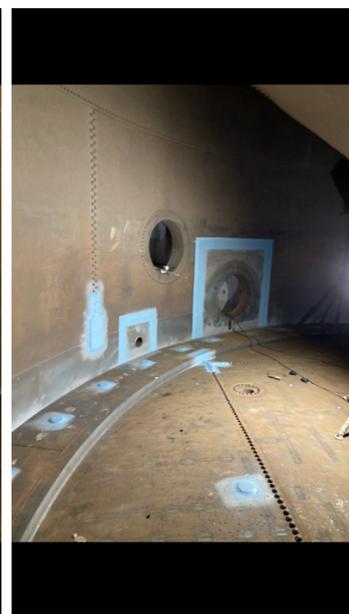
Section of the tank completed

Grit blasting of the section in order to achieve the required profile and cleanliness, before applying the paste grade Belzona 1511. Whilst in the overcoating window, Belzona 1391T was applied in 2 coats of 450 microns.
