# BELZONA REPAIRS AND PROTECTS DEMINERALISATION CHANNELS

Application: TCC-Tanks and Chemical Containment Areas

Customer Location: Nuclear Power Plant, Lancashire, UK

Application Date: October 2007

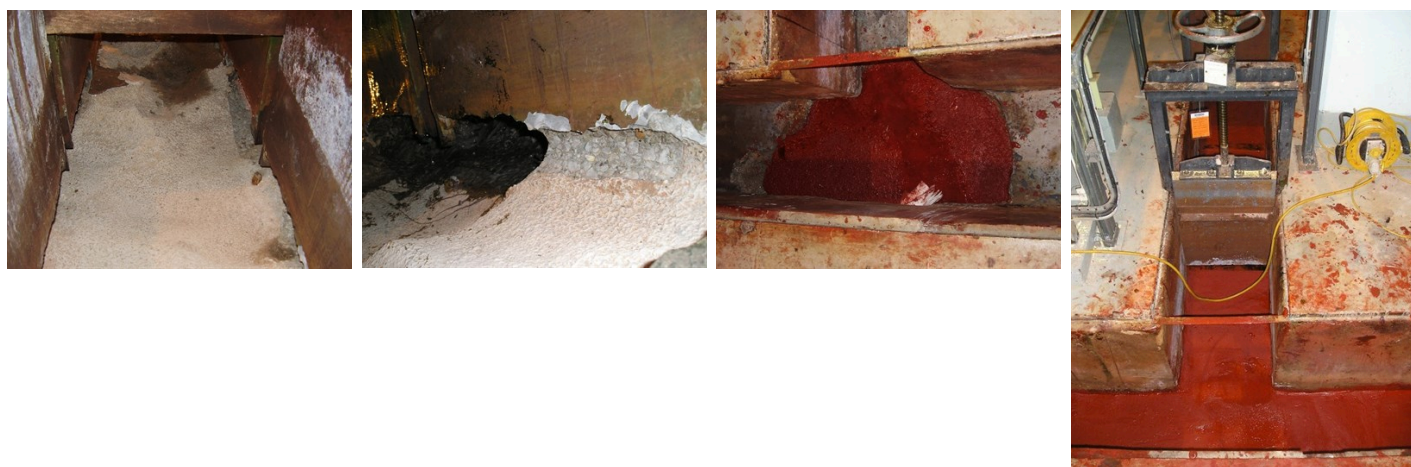
## Photograph Descriptions

## Problem

- \* Damaged concrete substrate ,
- \* Close up of damaged reinforced concrete substrate ,
- \* Filling in the prepared holes using Belzona 4181 ,
- \* Completed channel ,

A channel used to contain and transport sulphuric acid.

The application was carried out in accordance with Belzona Know-How System Leaflet TCC-9.

Time constraints due to demands on energy generation meant that Belzona were only allocated a short period of time for the repair work. Keeping to a schedule and force curing the product meant the power station incurred no fines for not being available to generate power when required.
