Belzona Repairs and Protects Circulating Water Pipelines

Industry: Power

Application: VPF-Valves, Pipes and Fittings

Customer Location: Daqing, Heilongjiang

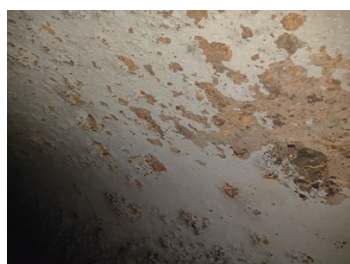
The circulating water pipeline has not been replaced in over 30 years since the factory was built and leakage problems often occurred due to corrosion. The customer's initial measure was to use wooden wedges to seal the leakage points and then weld steel plates around them. However, this approach could not address the fundamental problem.

Before Repair

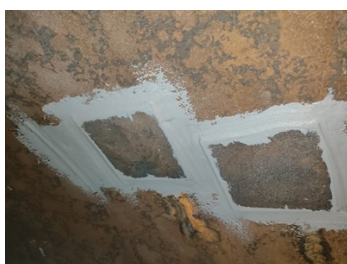
Use Belzona 1111 to repair pipe leakage

First, grit blast the pipeline and use Belzona 1111 to repair pipe leaks. The wooden wedges at the original leakage points are then sawed off and bonded with steel plates. There were more than 200 leakage points. Finally, apply two coats of Belzona 5811, with an average thickness of about 600µm.

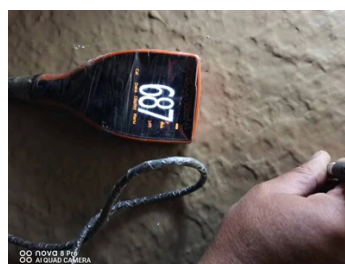
DFT test after applying two coats of Belzona 5811

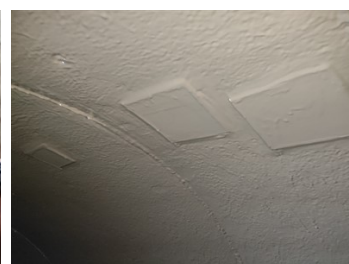
Application completed
