# Belzona Saves Rare Windmill

**Industry:** Buildings & Structures  
**Application:** RPA-Roof Problem Areas  
**Substrate:** Other  
**Products:** Belzona 3111 (Flexible Membrane), Belzona 3921 (GSC Surface Conditioner)

**Customer Location:** Derbyshire  
**Application Date:** September 2023

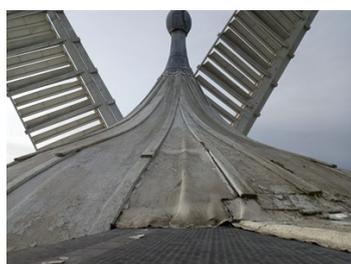
The cap of a rare windmill needed serious attention as the coating and protective material had degraded from the twin Larch skin. It was of paramount importance to rescue the windmill from any further trauma as it is the last stone bodied, 6 sail working windmill in the Country. The Cap and fan tail needed serious protection following repairs to the larch substrate as part of a refurbishment to this iconic working windmill

Close up of the condition of the cap, prior to restoration works

The old coatings and protective materials were removed and any necessary repairs were made to the Larch Substrate.. Belzona 3921 (GSC Surface Conditioner) was used prior to the Belzona 3111 (Flexible Membrane), which was reinforced by a selection of Belzona 9311 (Reinforcement Sheet) and Belzona 9431 (Reinforcement Tape).

Belzona 3921 (GSC Surface Conditioner) Applied to the Larch substrate

Belzona 3111 (Flexible Membrane) applied incorporating Belzona 9311 (Reinforcement Sheet) and some Belzona 9431 (Reinforcement Tape)

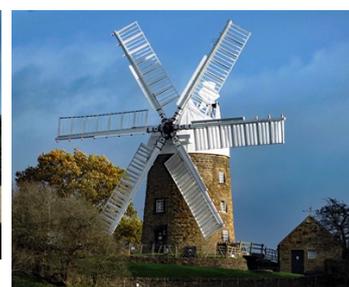
Back to its former glory

The Windmill now looks fantastic and is well protected against the elements, in the exposed hills of Southern Derbyshire

The cap was re-lifted back into position prior to the sails being re-bolted.
